***OIL MIST ELIMINATOR  
KF 25***

***949-9395 serie***

*(GB) INSTRUCTION MANUAL*

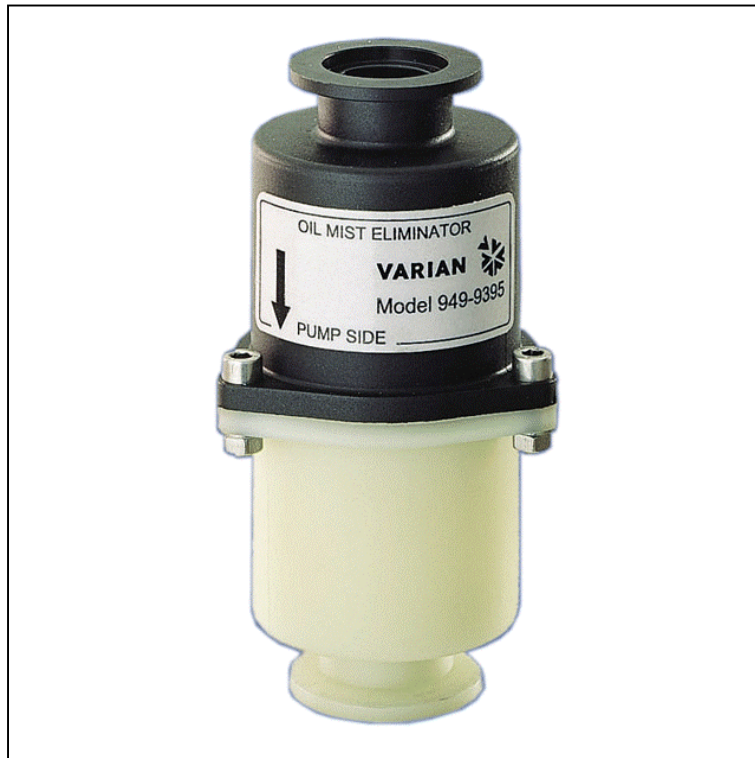
## ***Oil Mist Eliminator KF25***

It is assembled at the outlet of rotary pumps and the main purpose is to purify the exhaust gases from oil mists.

The oil mist filter is provided with a relief valve to protect the pump from overloads caused by excessive resistance on the-exhaust line.

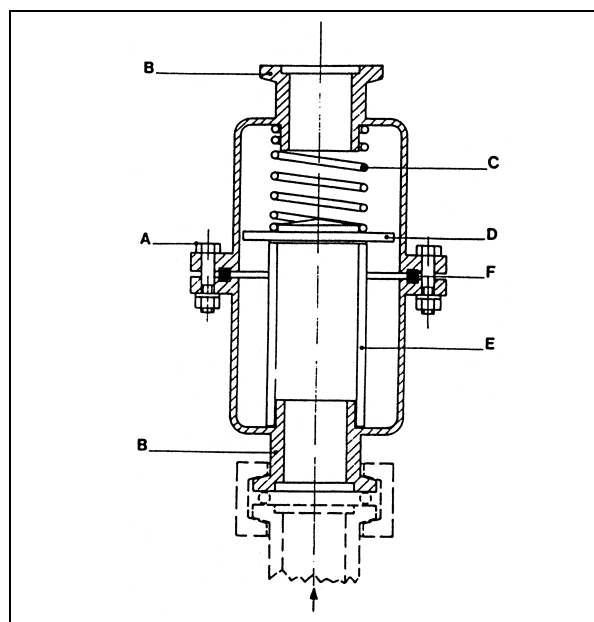
### Disassembly (see drawing):

Remove assembly screws A;

- Upper casing B
- Spring C
- Valve D
- Cartridge E
- O-ring F.

Install valve D with polished side toward cartridge, center spring C over valve D, fit gasket F in its groove, and cover entire assembly with the second casing B.

Tighten the two casings 8, using assembly screws A. After changing the cartridge several times, it may be necessary to replace the gasket OR 3212 as well as the centering ring gasket.

*Exhaust flange of the rotary pump*

- Remove flap valve (if any) from pump outlet port
- Find the end through which the white cartridge is visible and mount this end on the pump.

Install a new cartridge in the lower casing (B), pressing gently to be sure it is firmly seated.
